### Silicon identification

This errata sheet applies to the revision A, Z, Y and X of STMicroelectronics STM32L052x6/8 microcontrollers.

The STM32L052x6/8 devices feature an ARM® 32-bit Cortex®-M0+ core.

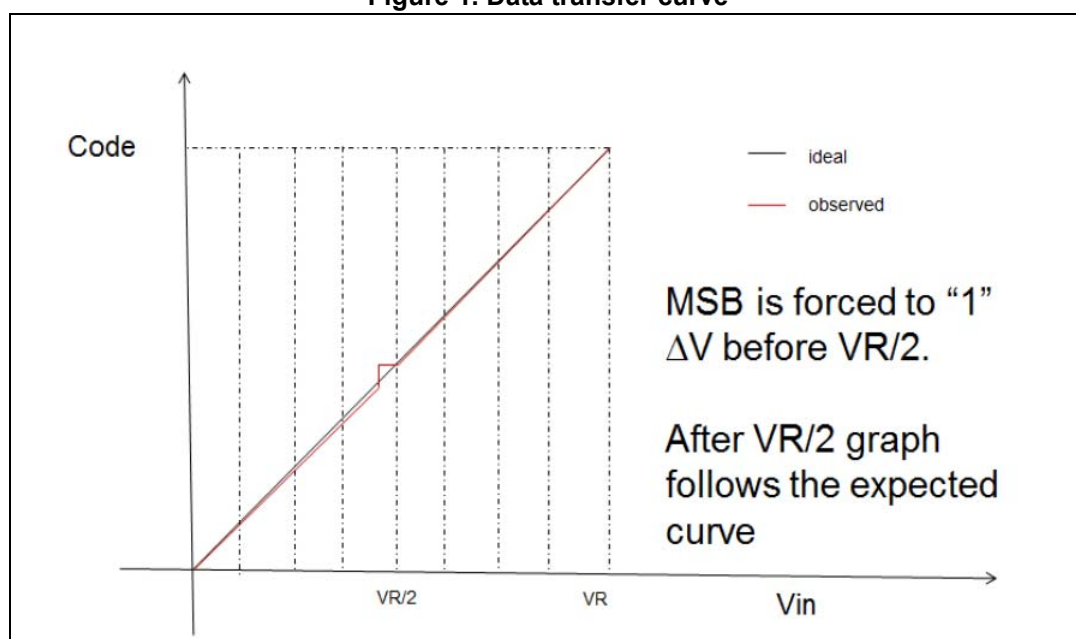
Figure 1. Data transfer curve

When  $V_{REF+}$  is lower than  $V_{DDA}$ , and only in this case, the data MSB is forced to '1' just before  $V_{IN}$  reaches  $V_{REF+}/2$ . As a result, the data transfer curve shows a discrepancy around  $V_{REF+}/2$  (see [Figure 1](#)).

*Note:* The transfer curve behaves as expected when  $V_{IN}$  is strictly lower or higher than  $V_{REF+}/2$ .
