## Applicability

This document applies to the STM32F058C8/R8 devices and their variants shown in [Table 1](#).

# 1 Summary of device errata

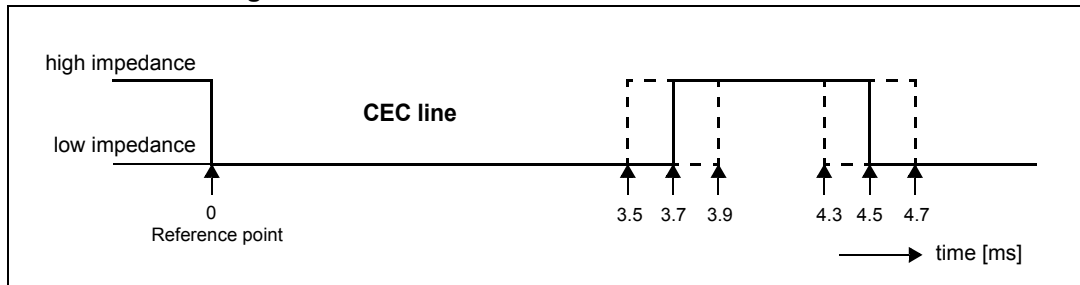
Figure 2. HDMI-CEC start bit format with tolerances

The start bit timing standard tolerances are shown in [Figure 2](#). The start bit is initiated by the device by driving the CEC line low (reference point). After 3.7 ms, the device releases the CEC line and starts checking its level. The following conditions must be met for the start bit to be valid:

If one of these conditions is not met, the transmission is aborted and never automatically retried. No error flag is set and the TXSOM (Tx Start Of Message) bit is not cleared.

The only way to detect this error is for the application software to start a timeout when setting the TXSOM bit, restart it upon ARBLST or any RX event (as the transmission can be delayed by interleaved reception), and stop it upon TXBR (proof that the start bit was transmitted successfully) or TXEND event, or upon any TX error (which clears TXSOM). If the timeout expires (because none of those events occurred), the application software must restart the HDMI-CEC peripheral and retransmit the message.
